## CITY OF NEWMAN PUBLIC WORKS

### Historic Flood Information

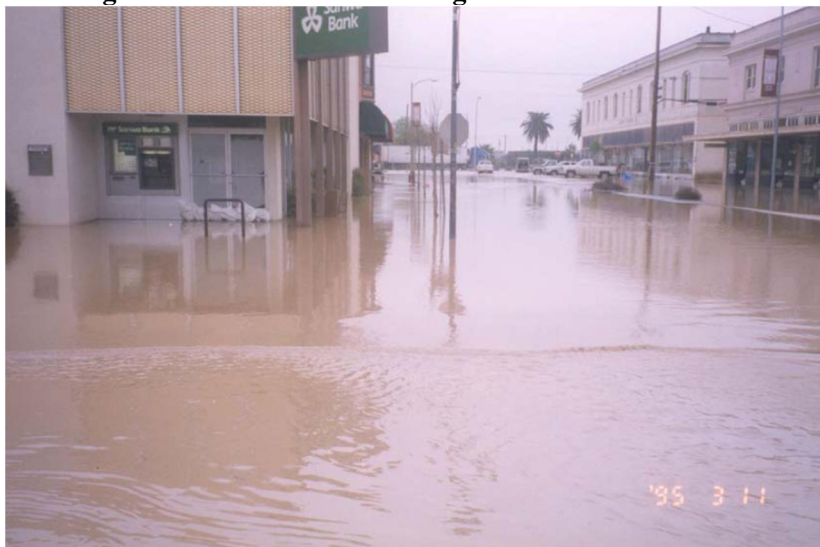
**Figure 1: March 1995 Flooding from Orestimba Creek**

In March 1995, Newman experienced the worst flood in its 107-year history. On March 10, 1995, the USGS gauge upstream of the California Aqueduct registered a peak flow of 12,000 cfs. On the same date, the USGS gauging station Orestimba Creek at River Road registered a peak flow of 2,650 cfs. This shows that significant flood volume was conveyed overland across agricultural fields with a portion of the flow inundating the City of Newman.

Structures within the town were flooded by over two feet of sediment-laden water. A convalescent hospital located on the north side of the city was entirely inundated by 2 feet of water in the building and 4 feet of water in the parking lot. Sixty five residents were evacuated by a Medi-Flight helicopter after a failed attempt to use two ambulances and a school bus. Many public streets and highways, including State Highway 33, were closed. These road closures limited or, in some cases, prevented access for emergency vehicles which resulted in diminished local and regional emergency response capabilities. Similar public health risks caused by area flooding included floodwater affected domestic water wells and individual septic systems, many of which were rendered unusable.
